DEPARTMENT OF TRANSPORTATION**DIVISION OF ENGINEERING SERVICES**

Contract #: 04-0120F4Cty: SF/ALA Rte: 80 PM: 13.2/13.9File #: 70.28**WELDING INSPECTION REPORT****Resident Engineer:** Pursell, Gary**Address:** 333 Burma Road**City:** Oakland, CA 94607**Report No:** WIR-004557**Date Inspected:** 04-Nov-2008**Project Name:** SAS Superstructure**OSM Arrival Time:** 800**Prime Contractor:** American Bridge/Fluor Enterprises, a JV**OSM Departure Time:** 1800**Contractor:** Japan Steel Works**Location:** Muroran, Japan**CWI Name:** Chung Fu-Kuan**CWI Present:** Yes No**Inspected CWI report:** Yes No N/A**Rod Oven in Use:** Yes No N/A**Electrode to specification:** Yes No N/A**Weld Procedures Followed:** Yes No N/A**Qualified Welders:** Yes No N/A**Verified Joint Fit-up:** Yes No N/A**Approved Drawings:** Yes No N/A**Approved WPS:** Yes No N/A**Delayed / Cancelled:** Yes No N/A**Bridge No:** 34-0006**Component:** Tower, Deviation and Jacking Saddles**Summary of Items Observed:**

WELDING INSPECTION REPORT

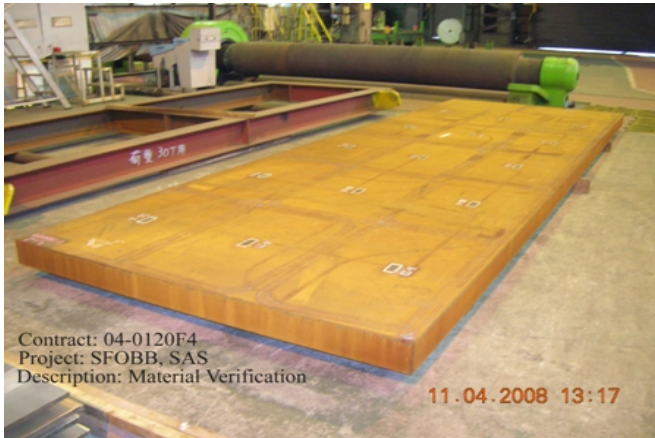
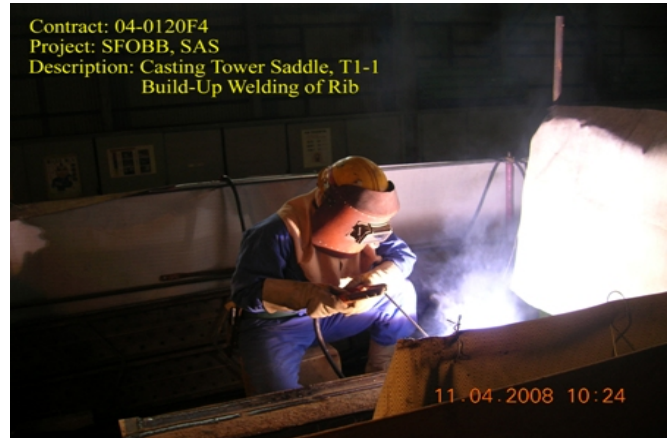
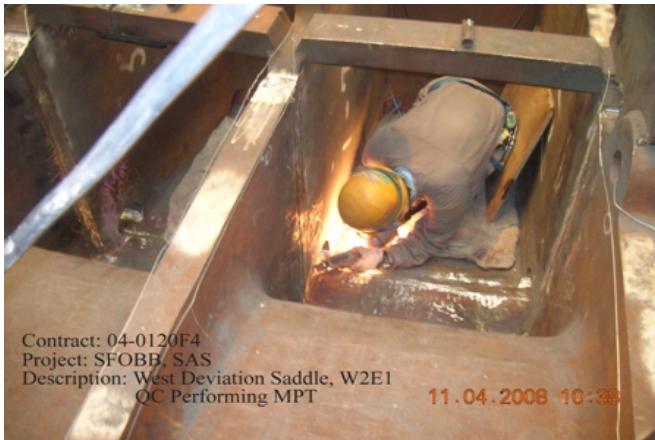
At the start of the shift the QA inspector traveled to the shop to observe the scheduled work performed on the casting stem and rib on the Tower Saddle identified as T1-1. The weld build-up was performed on the casting ribs which were identified as 7Y-5U-1, 7Y-5U-3, 7Y-9U-2 and 7Y-9U-3 utilizing the Welding Procedure Specification (WPS) SJ-3012-1-1. The WPS was also used by the Intertek Testing Service (ITS) Quality Control (QC) Inspector Chung Fu-Kuan as a reference during QC verification of the Alternating Current (AC) welding parameters. The SMAW process was performed by the following JSW welding personnel; Kato Ryota ID 07-4510, Yoshita Nakano 08-2011, Taksuya Naitoh ID 71-2736, Kei Nakasato ID 91-2247 and Kazuya Iwamoto ID 07-4366. The tower saddle was positioned so that the performance of the welding was in the flat position with the work in the horizontal plane and the weld metal deposited from above.

casting to the structural steel rib connection on the West Deviation Saddle identified as W2E1. The testing was performed at the area of the weld extension plates which were removed and ground to a bright metal. The continuous MPT was performed by Nikko Inspection Services (NIS) technician Kazuya Kobayashi utilizing the AC Yoke, Type A-6 testing unit manufactured by Eishin Kagaku Co., Ltd. The testing was conducted utilizing the JSW procedure identified as SF-MT-01.

The QA inspector also observed the build-up repair welding of the casting on the West Deviation Saddle identified as W2E1. The welding was performed on the rib identified as 1-15. The welder, Morohashi Satoshi ID 91-2255, utilized the SMAW process as per the Welding Procedure Specification (WPS) SJ-3026-2 which was also used by JSW Welding Engineer Tomio Imai during the verification of the AC welding parameters.
